Gulfport, Mississippi - The Impact of Hurricane Katrina
 NOAA Aerial Imagery Acquired August 30, 2005

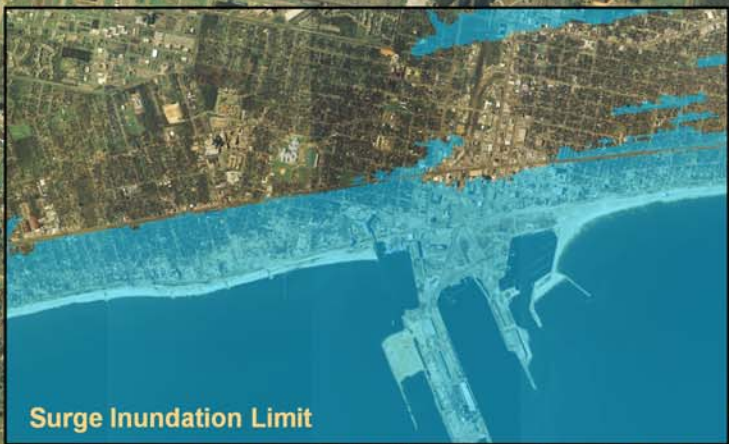
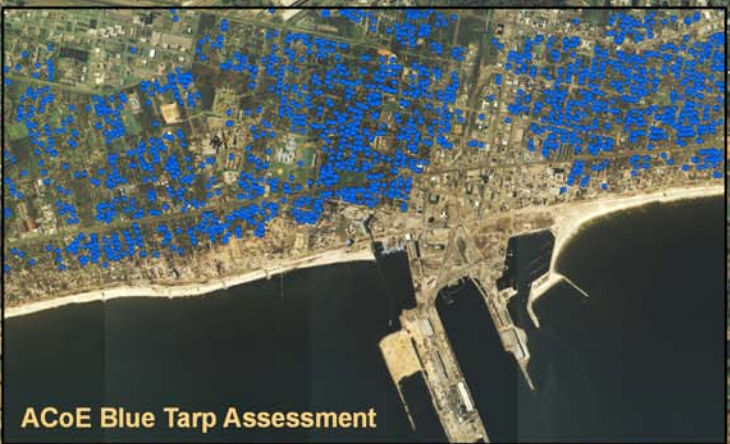
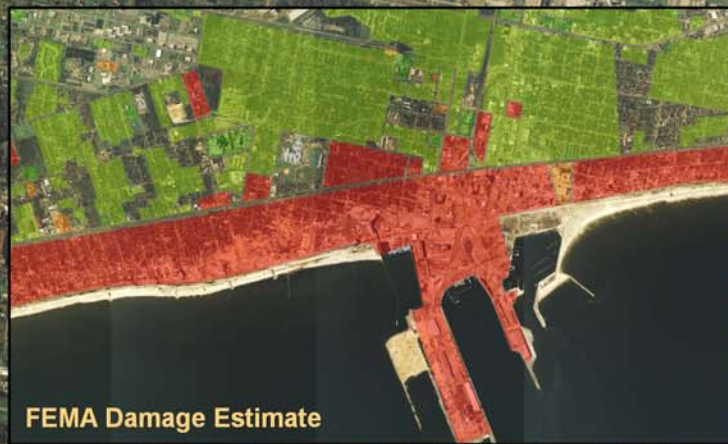
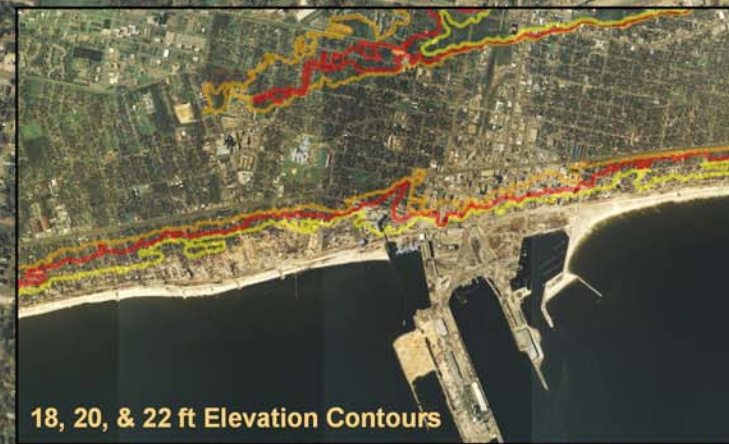
- Surge Inundation Limit - FEMA assessment of extent of high water, based on after storm measurements and topology
- Army Corps of Engineers (ACoE) Blue Tarp Assessment - aerial imagery derived residential building assessment with minor roof damage, assessment based on HAZUS-MH Technical Manual roof damage classification. This is equivalent to roof cover loss greater than 2% but no more than 15%.

- FEMA September 9, 2005 Damage Estimate -
- Limited - Generally superficial damage to solid structures (e.g., loss of tiles or roof shingles); some mobile homes and light structures are damaged or displaced.

- Moderate - Solid structures sustain exterior damage (e.g., missing roofs or roof segments); some mobile homes and light structures are destroyed, many are damaged or displaced.

- Extensive - Some solid structures are destroyed; most sustain exterior and interior damage (e.g., roofs missing); most mobile homes and light structures are destroyed.

- Catastrophic - Most solid and all light or mobile structures destroyed.

- 18 foot elevation contour
- 20 foot elevation contour
- 22 foot elevation contour
